City of Baltimore Wet Smoke and Dyed	Page 1 of 1	
Sewershed: Gwynns Falls	Company: Savin	Date: 4/23/2009
Test to be performed: Smoke Dyed Water X	Ground Condition: Dry ✓ Damp ☐ Wet ☐	Supervisor: JAW
Manhole_ID: S05SS_012MH	Test ID: <u>D1032-015001</u>	Notification Made: NA (Residents, Fire, 311)

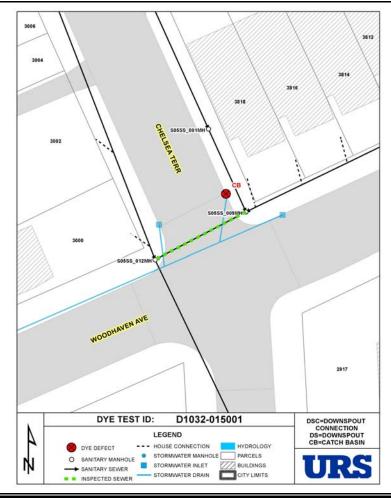
Field Sketch: Show all manholes with Numbers, Blower Placement Locations, Sandbag or Isolation Locations, Street Names, Building Addresses and Locations, Defect Locations and Photo Numbers.

Defect Loc	Obs_ClockFrom	Obs_ClockTo	Observation	Obs_Remarks
0			Start of Survey	
0			Manhole	S05SS_009MH
0			Dye Test Visible	IR @ jt of incoming line, 1/2 GPM
0			Dye Test Visible	IN MANHOLE AT CONN. OF OUTGOING
0			General Observation	IR @ INCOMING LINE 6 oc
2			Dye Test Visible	IR @ FC, 5 gpm
2	12	12	Fracture Circumferential	
3.900000095			Dye Test Visible	@ IR & FM, 4 gpm
3.900000095	12	12	Fracture Multiple	
10			Abandoned Survey	NO MORE DYE VISIBLE
